Manhole Inspection Summary

Manhole # S13S__022MH

Location Address: **2900 Cowan Ave.**

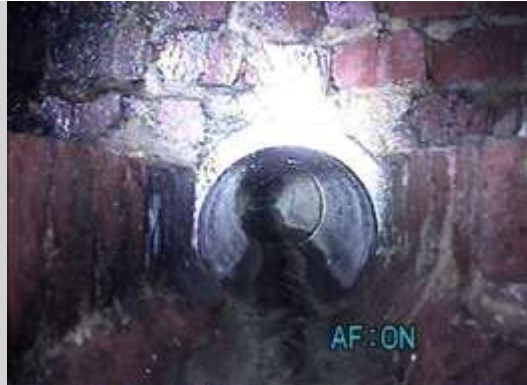
12 O'Clock Outflow

Pipe Height: **8.4** (in.) Rod and Bar (Angled)
Pipe Material: **Clay** ☐ Pipe Lined
Invert Depth: **8.91** (ft.) Flow Characteristics: **Slow**
Deposits: ☒ None ☐ Mud ☐ Sludge ☐ Debris ☐ Grease
Silt Depth: **0** (in.) Deposits Extent:
Infiltration: **None** Pipe Seal Cond: **Sound**

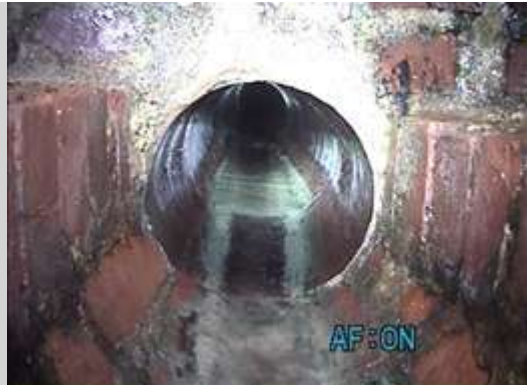
6 O'Clock Inflow

Pipe Height: **8.4** (in.) Rod and Bar (Angled)

Pipe Material: **Clay** ☐ Pipe Lined

Infiltration: **None**
